SEAL Troubleshooting Procedure

When no ink comes out of a cartridge that has been well primed and nozzle checked, it could be caused by a clogged print head or most likely the valve at the bottom on the cartridge is not opening properly. The following procedure deals with adjusting the seal and valve mechanism to ensure that ink will flow properly when installed in the printer.

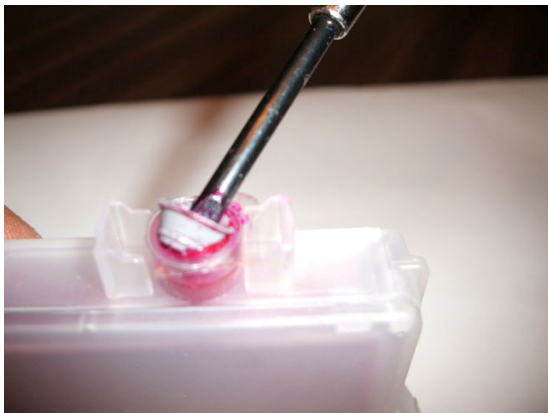
If it is not flush or you are not sure, simply pull out the ring using a miniature screwdriver and clean both the ring and cartridges with a Kleenex.

Note: Be very careful to do this slowly and carefully so as to not to lose the spring valve or cause ink to spill.

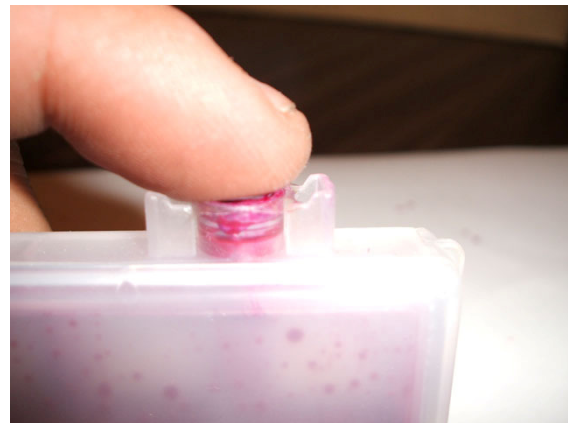
Simply replace the rubber seal so that it is flush and even. Also check that the spring valve is sealing Properly.

This procedure will ensure that the spring valve is set in a position to allow it to be opened easily when inserted in the printer.
