SEAL Troubleshooting Procedure

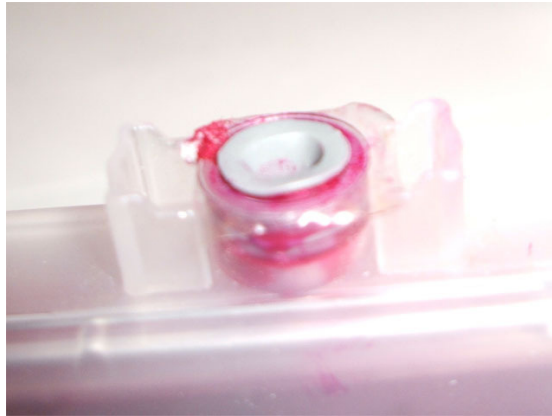
Check that the grey rubber seal ("O-Ring") is flush with the bottom of the cartridge.

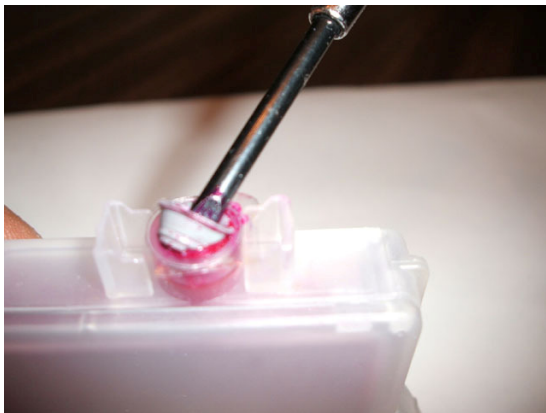
If it is not flush or you are not sure, simply pull out the ring using a miniature screwdriver and clean both the ring and cartridges with a Kleenex.

Note: Be very careful to do this slowly and carefully so as to not to lose the spring valve or cause ink to spill.
